COY-TR-66-509

MAY 1966

**AIRMUNITIONS TEST REPORT**

**MINUTEMAN  
(LGM-30)  
IMPALER TEST**

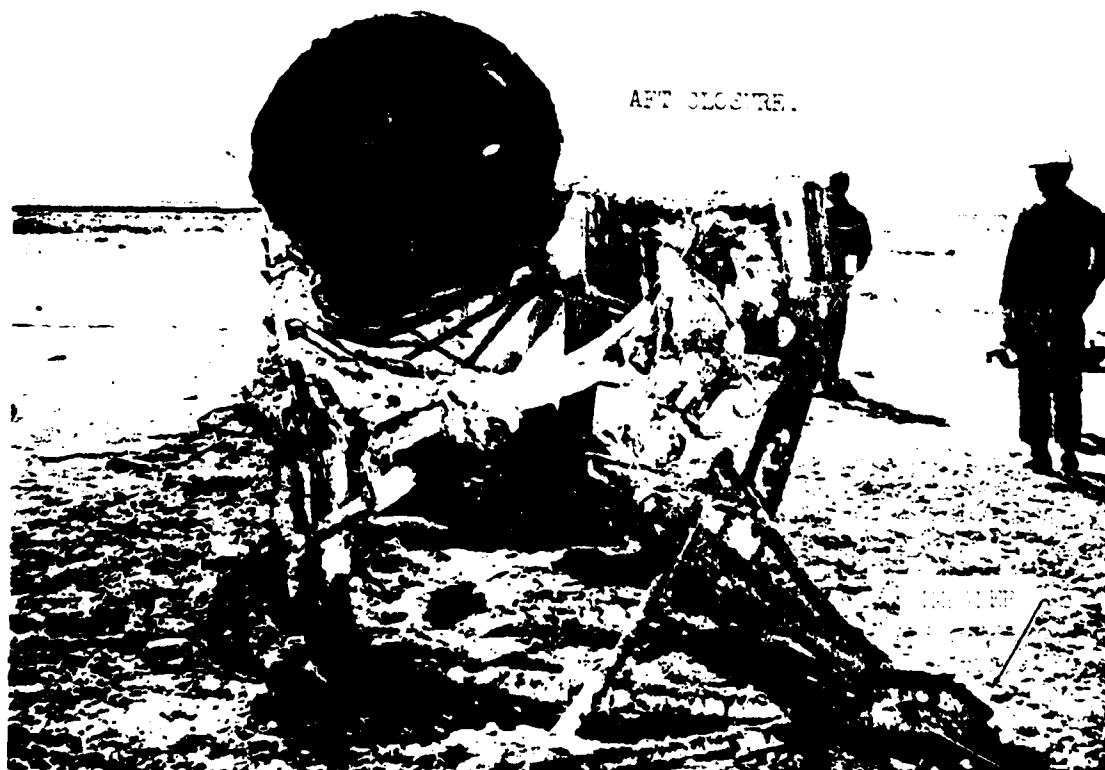
FIGURE 9. 1st STAGE MOTOR AND IMPALER.

First stage motor thrust was reduced almost to zero after the forward dome blew out. The motor and carriage together with the second stage motor and carriage moved down the rails until the second stage impacted the third stage. Then the third stage impacted with the impaler tearing it from the rails. The first stage motor and carriage came to rest with the front carriage wheels at the end of the rails. The motor case was almost completely consumed. The only intact or recognizable portion was the aft closure and nozzle assembly (Figure 9).

The motor cartwheeled past the impaler. Two nozzle inserts were blown forward of the rails and two were blown behind the rails (Figure 16). The impaler was torn from its mounts and dropped down in front of the rails (Figure 9). The motor, burning from both ends, moved forward a distance of about 122 feet (Figure 17). A large section of propellant fell out of the case and burned separately about 150 feet from the impaler end of the rails. Between the front of the rails and the final resting place, the shaped charge around the forward "Y" joint functioned, cutting the remaining portion of the dome away from the case (Figure 18). The shaped charge along the raceway burned away without detonating since a portion of the intact raceway was found. It cannot be positively determined if the shaped charge around the aft "Y" joint detonated or burned away as the case was badly burned in the area (Figure 17).

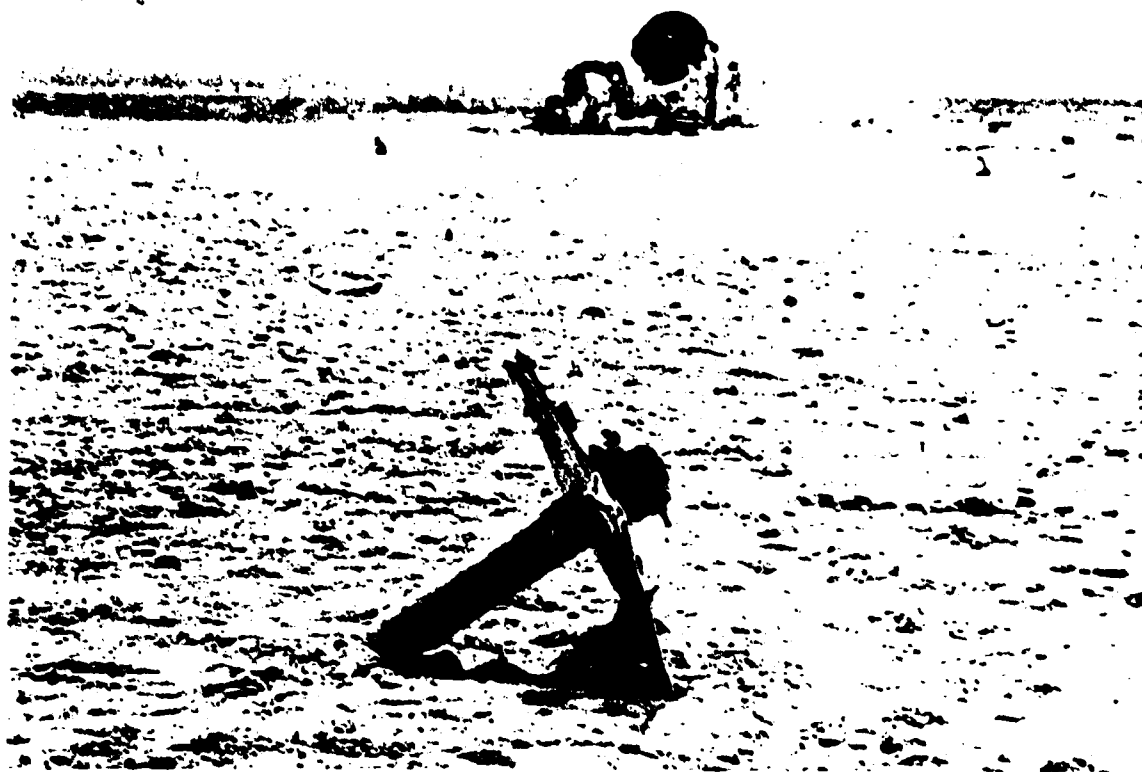
FIGURE 13. 2d STAGE PYROGEN AND S&A DEVICE.

A section of the forward dome was found 206 feet in front of the rails (Figure 13). This was an 18 inch diameter fragment from the center of the case containing the S&A Device and the pyrogen unit. The internal rubber liner was attached. The pyrogen unit and all internal surface of the fragment were unburned and free from the smoke deposits. The outer surface of the fragment and the S&A Device were heavily blackened. This indicated that the outer surface had been exposed to flame and that the forward dome had fragmented before the propellant in the second stage motor had started to burn at the front end of the motor.

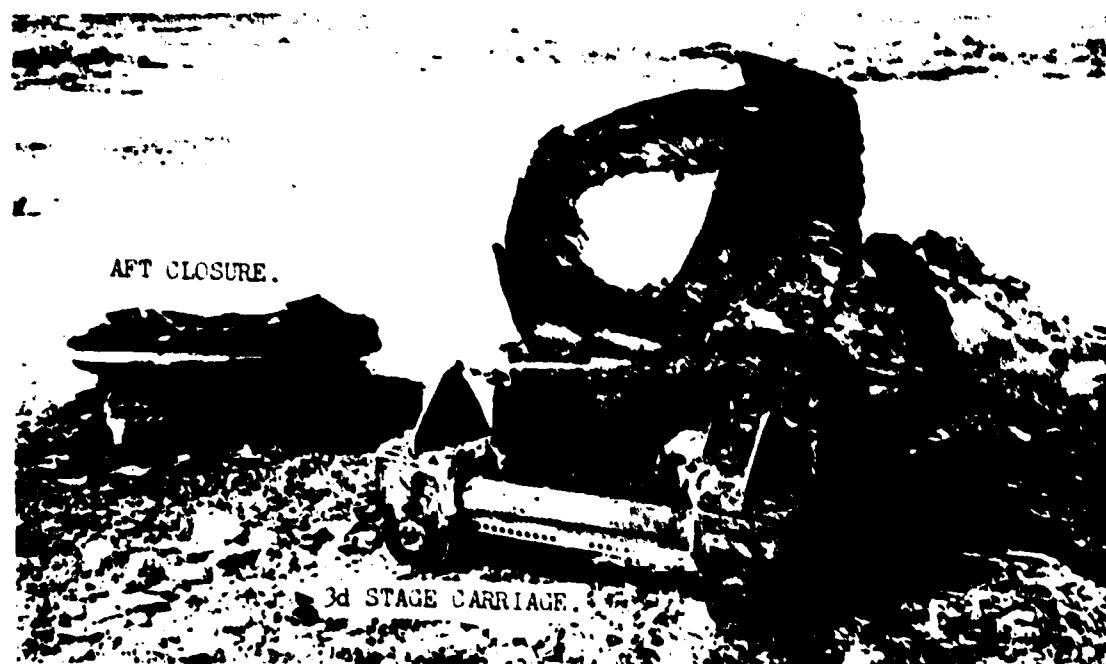
FIGURE 14. 2d STAGE MOTOR.

The second stage motor knocked the third stage motor from its carriage, the second stage motor left its carriage and landed on the third stage carriage. The second stage motor in the third stage carriage, now burning from both ends, followed the third stage motor off the rails and landed about 44 feet in front of and slightly to the right of the rails. The propellant burned out of the case, the case was almost consumed except for a section at the bottom and the aft closure. The aft closure fell away from the main case portion and was found immediately behind the case (Figure 14).
